NATIONAL TRANSPORTATION SAFETY BOARD

WRECKAGE EXAMINATION SUMMARY

WPR21LA145

Location: Marana, Arizona
Date: 03/28/2021
Aircraft: Cirrus SR22; N644SR
NTSB IIC: James Bledsoe

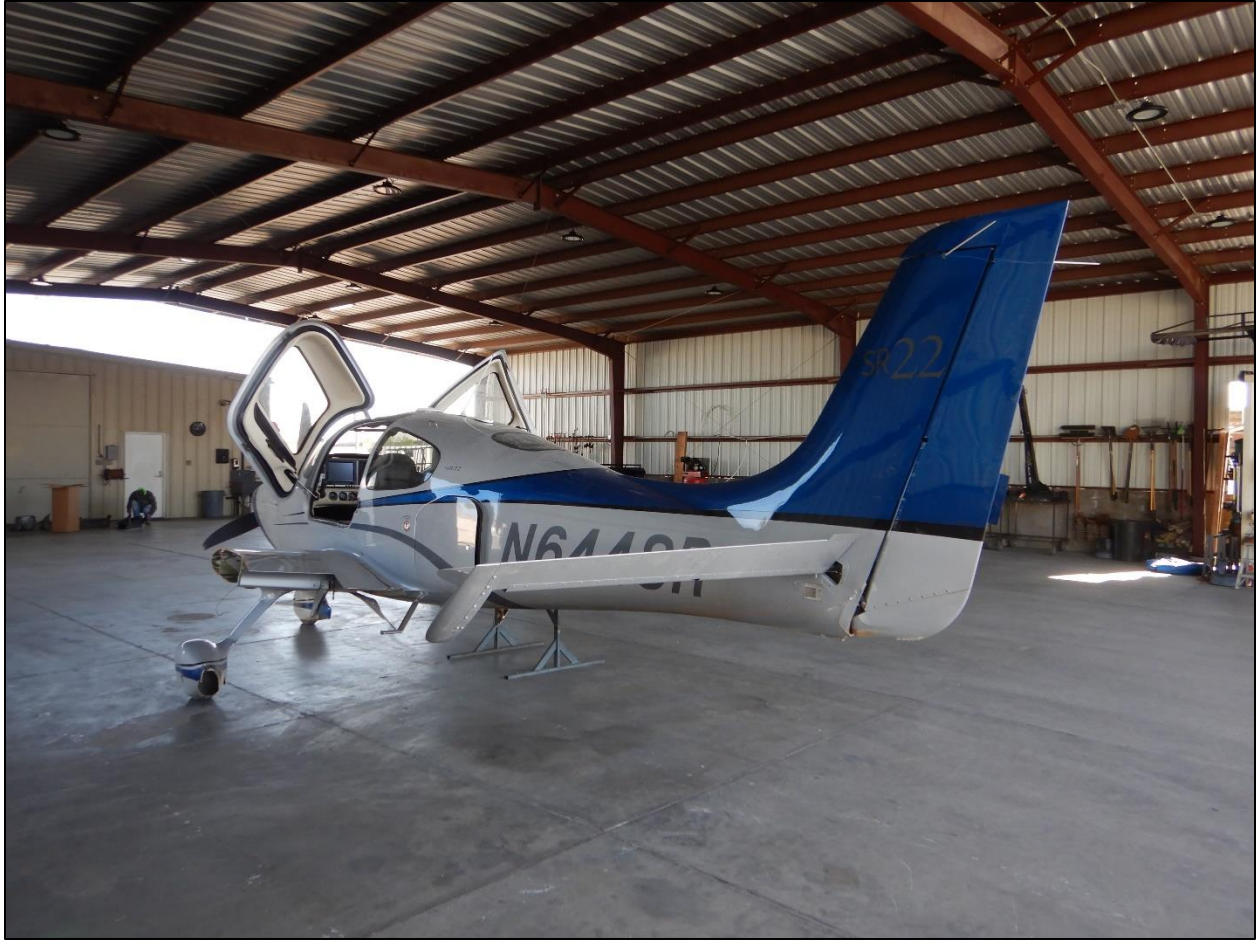
Both wings were cut and removed near the wing root, and the right horizontal stabilizer was also cut near the fuselage to facilitate the relocation of the wreckage. The fuselage was intact, and the lower aft fuselage had ground impact damage. The engine cowling was attached, and oil streaked from both sides of the cowling.

Figure 1-Main wreckage positioned during the examination.

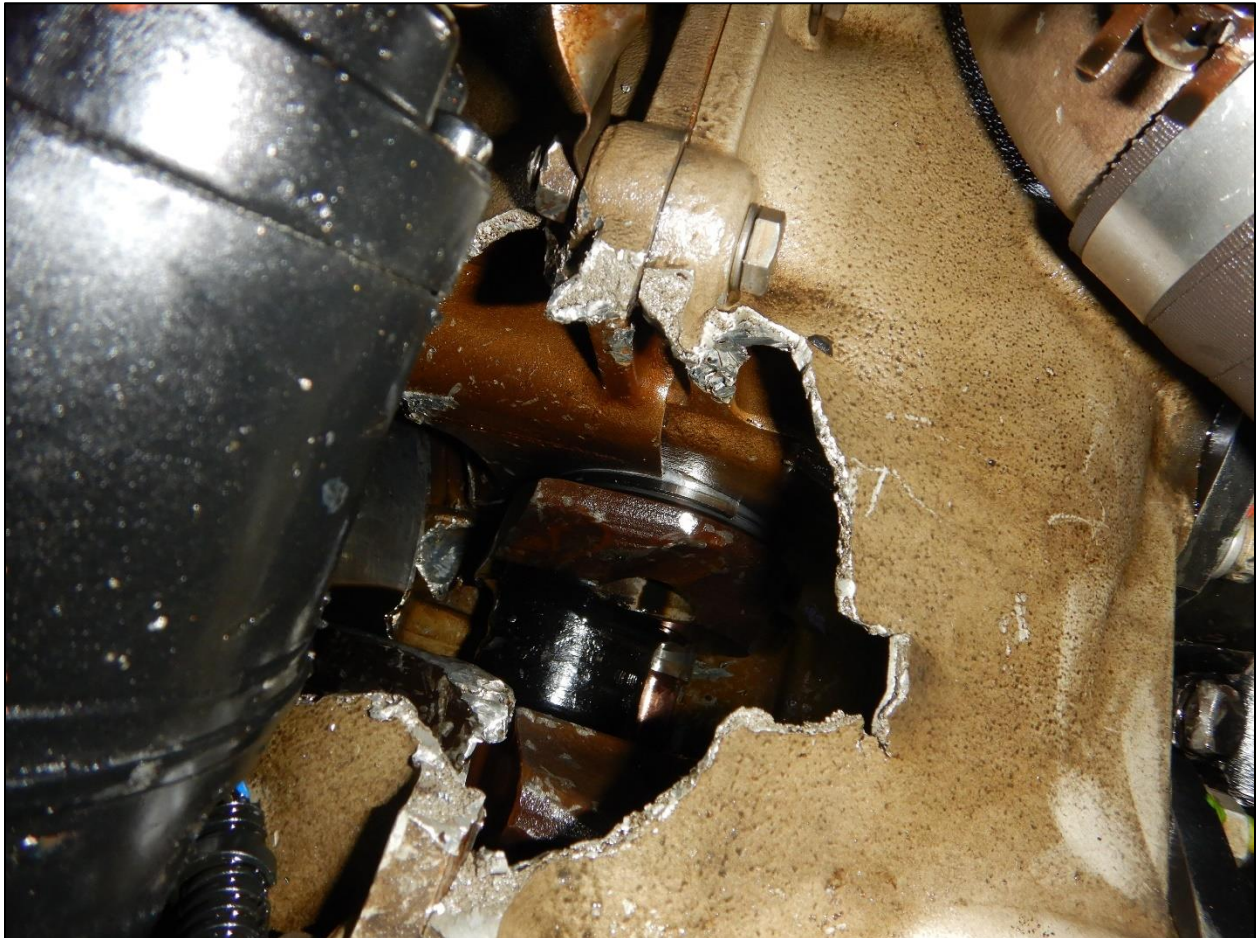
Examination of the Continental IO-550-N engine (Serial No. 689836) revealed that the engine remained attached to all four engine mounts. The upper cowling was removed and impact damage (from the underside) was noted near the center of the cowling. Piston and crankshaft sections were found on baffling on the right side of the engine. The magnetos separated from their crankcase mounts and remained in their relative areas. The magneto ignition leads had impact damage. The No. 2 connecting rod, piston and crankcase material were found outside the crankcase near the magnetos. The No. 2 connecting rod had mechanical damage. The connecting rod end cap and No. 2 piston pin was also found outside the crankcase between cylinders No. 1 and 2. The end cap had mechanical damage and was flattened. One bolt end was attached to the cap end. Underneath the magnetos the crankcase had a large opening, measuring about 5 inches in diameter. The crankshaft and the No. 2 cylinder bay area had mechanical damage. The No. 2 connecting rod bearing journal was black in color (thermal discoloration) and had mechanical damage. A No. 2 main bearing half was visible and was not positioned properly in the saddle bearing support. (See figure 2.)

Figure 2-Crankcase damage and view of the crankshaft and interior components.

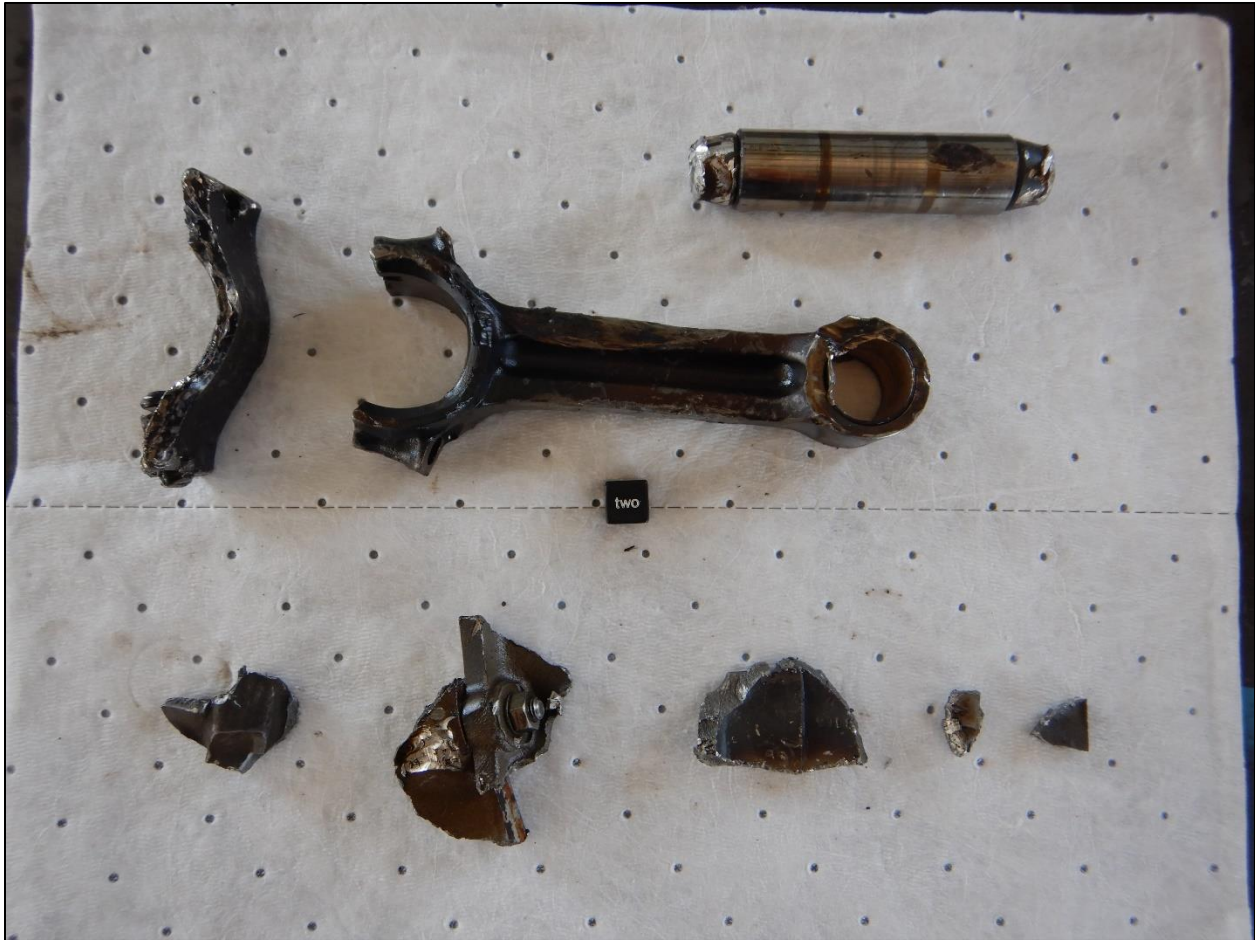
Figure 3-No. 2 connecting rod, piston pin and crankcase and piston material.
